Spot Safety Project Evaluation

Spot Safety Project # 01-99-227

Spot Safety Project Evaluation of the “Vehicles Entering When Flashing” warning flasher installation at the intersection of US 17 at SR 1338 (Wynn Fork Rd) in Perquimans Co.

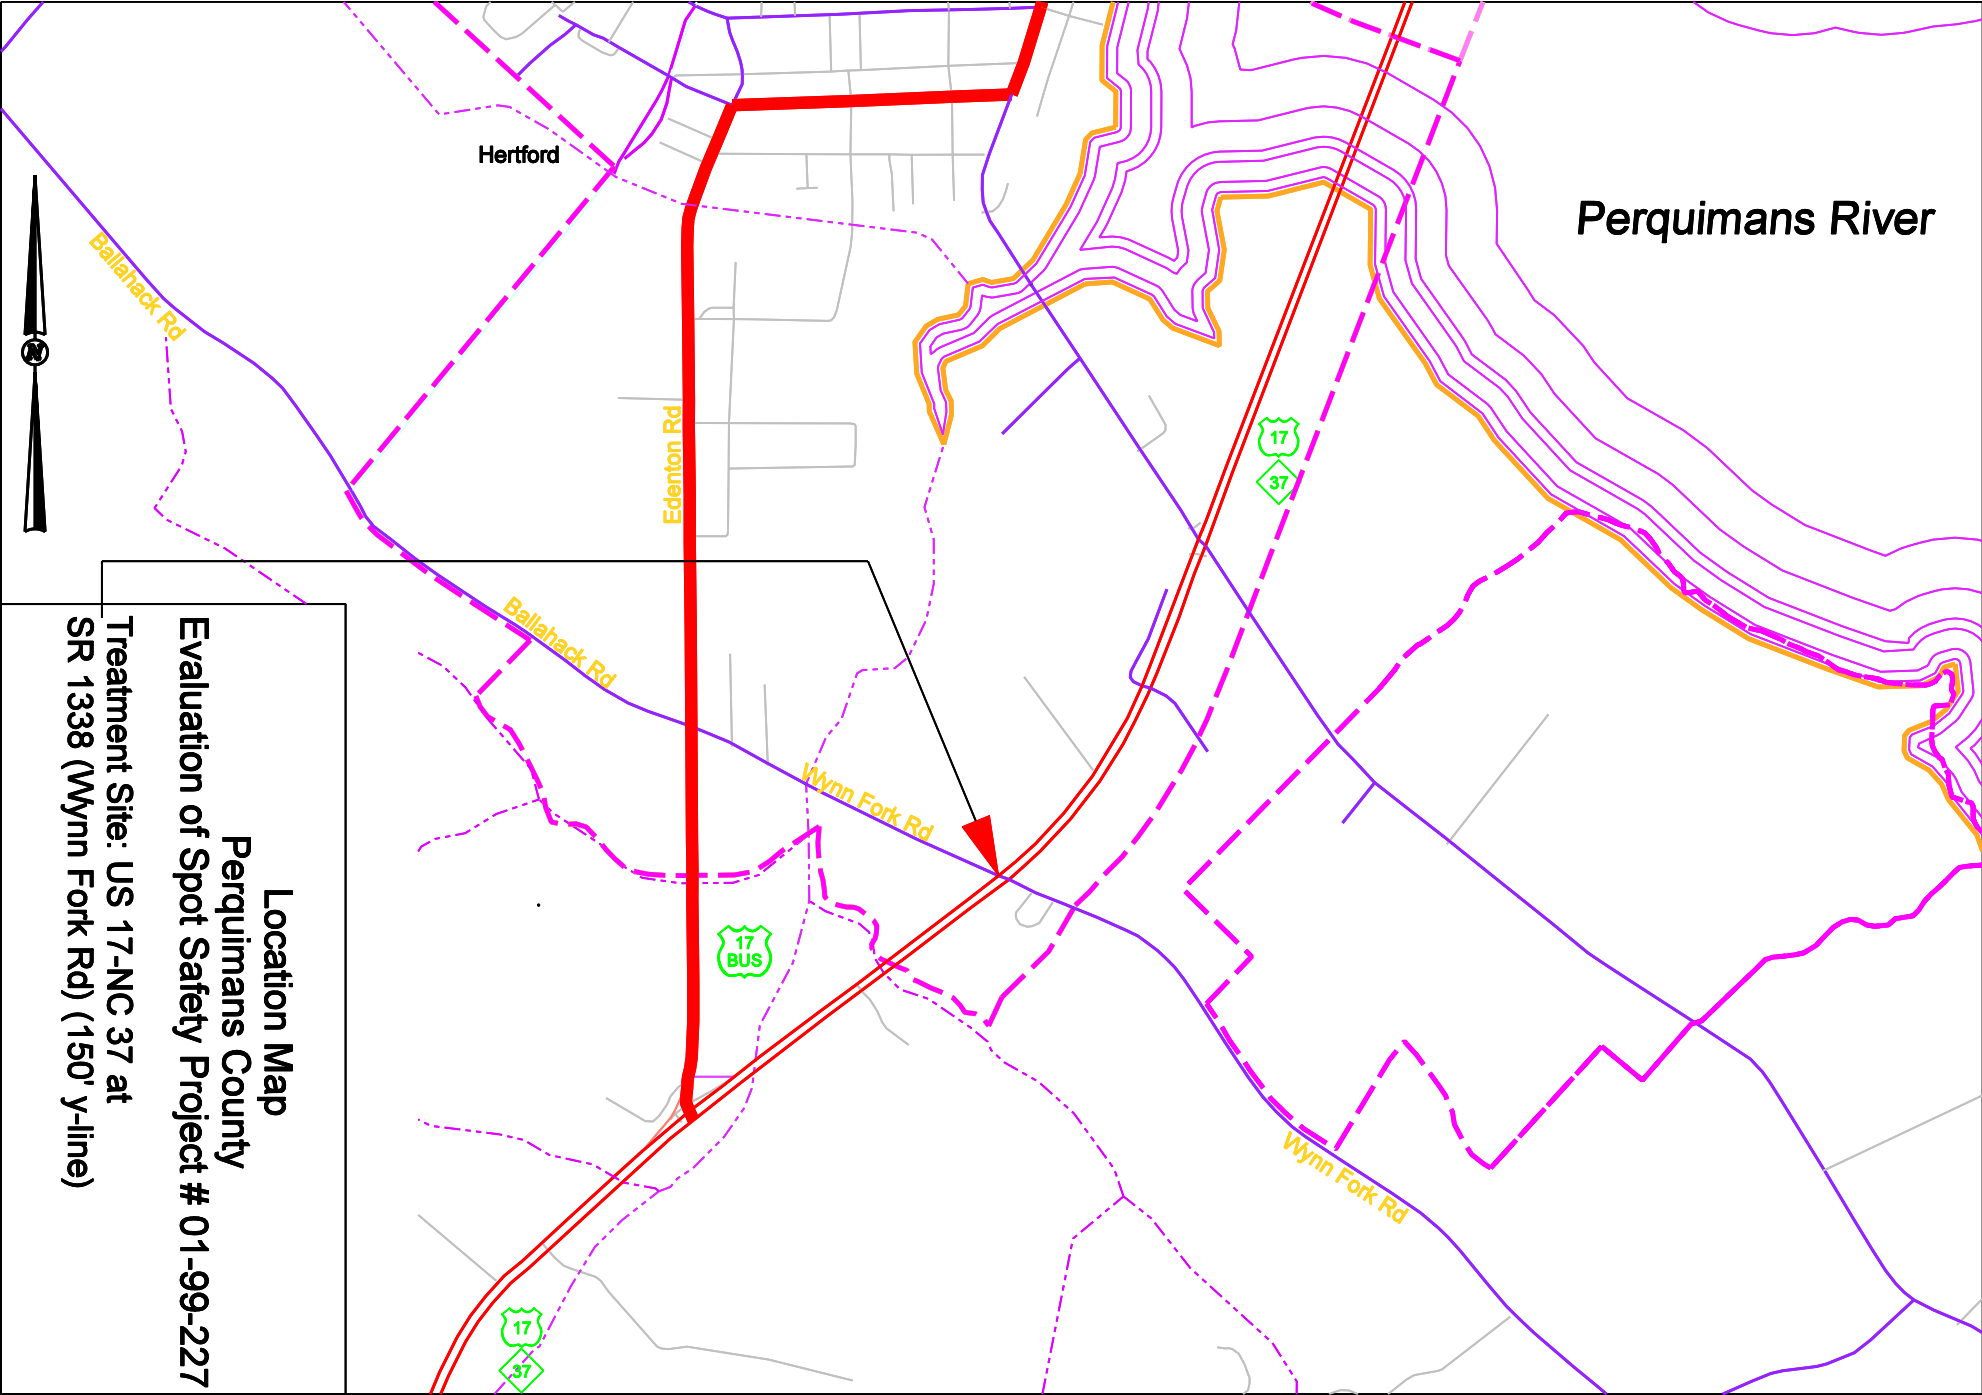
Referencing the collision diagram there is a crash pattern between the northbound and eastbound vehicles in the before and after periods. There is a slight skew at the intersection that may place US 17-NC 37 northbound in a vehicle's (B or C pillar) blind spot when attempting to cross the intersection on SR 1338 eastbound. During the site visit a truck was crossing US 17-NC 37 eastbound, the flasher was activated initially but turned off while the truck was waiting in the median for a safe gap in traffic (see first photo).

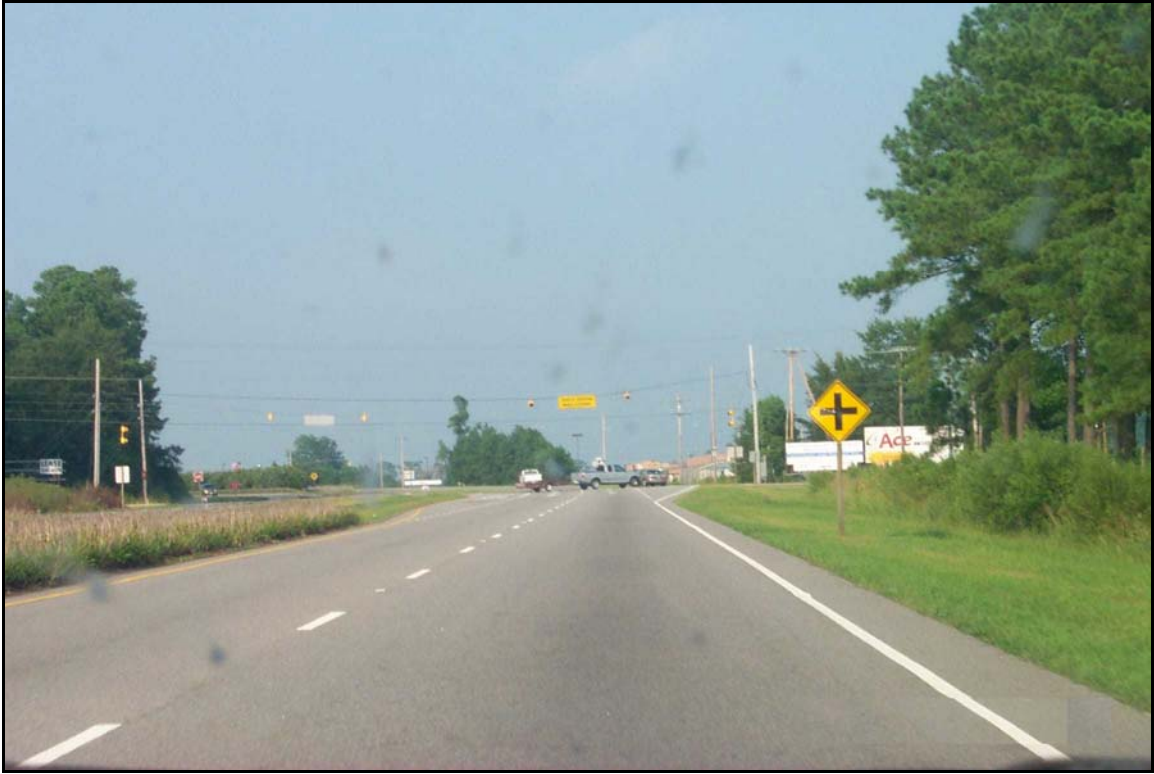
Driving north on US 17-NC 37
